WADC TECHNICAL REPORT 52-63
ASTIA DOCUMENT NR AD 142103

EJECTION SEAT TESTS CONDUCTED
ON THE 10,000 FOOT AERODYNAMIC
RESEARCH TRACK AT EDWARDS AIR FORCE BASE

C. K. HODELL
A. H. ROSNER

NOVEMBER 1957

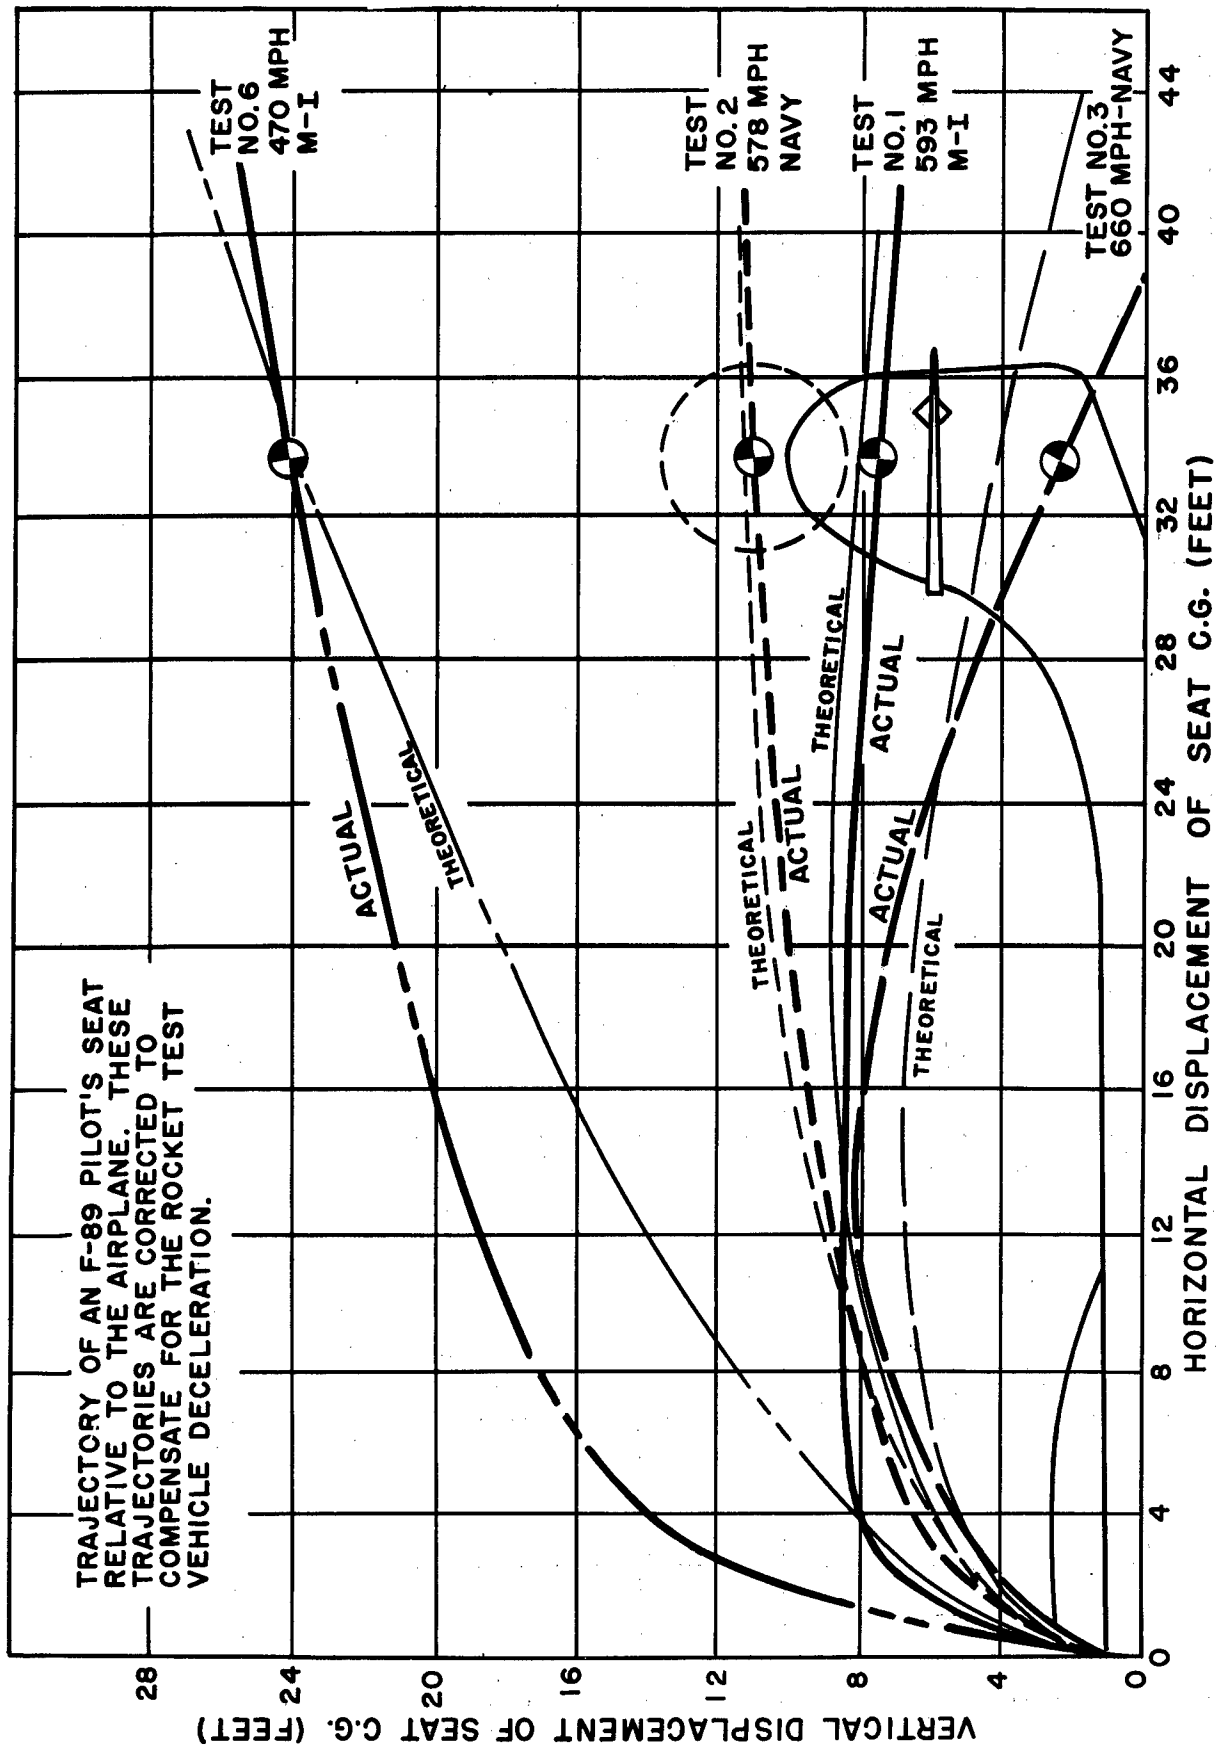
FIGURE 29. EJECTION SEAT TESTS, 10,000 FOOT FREE AIR TEST FACILITY TRACK, EDWARDS AIR FORCE BASE.

"O" IS THE POSITION OF THE C.G. OF THE PILOT-SEAT CONFIGURATION AS MOUNTED IN THE AIRPLANE.

The results of this test, utilizing the Navy NAMC Type I fully guided catapult stroke are plotted in Figures 30, 31 and 32. The tail clearance is shown in Figure 29 and a summation of the test is given in Appendix I. This run was considered successful even though the drive motor of the recording oscillograph failed to rotate the drum. No oscillograph recordings were obtained. Photographic coverage was complete as shown by Figure 33.
